**PHASE I ENVIRONMENTAL SITE ASSESSMENT
PROPOSED GROVER BEACH LODGE
GROVER BEACH, CALIFORNIA**

PROJECT NO. SL07154-2

July 30, 2010

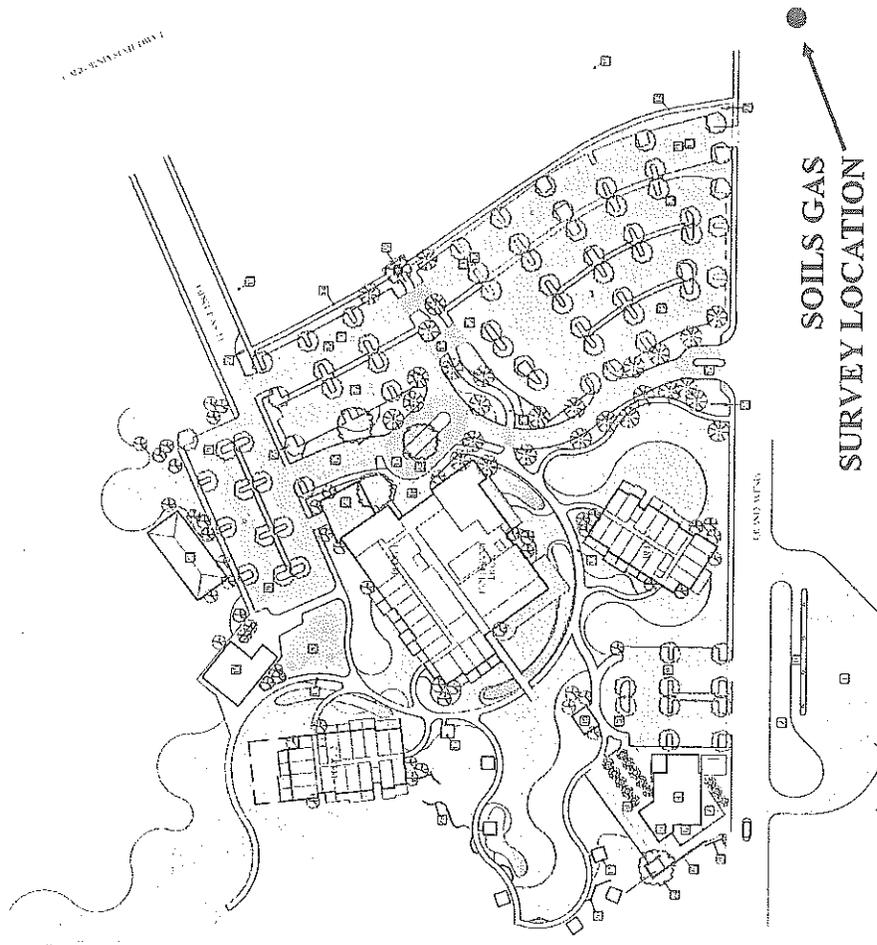
PLATE
1
PROJECT NO:
SL07154-2

**SCHMATIC MASTER PLAN, OPTION 1 - 150 ROOMS
GROVER BEACH LODGE**

- **Based on a soil gas survey to the southeast of the Site, one soil sample contained a gasoline range hydrocarbon concentration of 57 to 74 ug/L at a depth of 3 feet below ground surface (see Plate 1 for location). The extent of gasoline range hydrocarbons is unknown and contractors are recommended to be notified of this finding prior to beginning construction.**

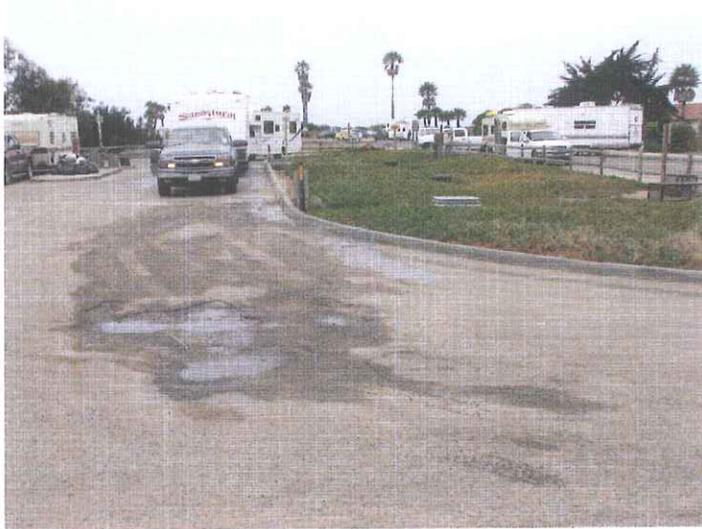
Photo #1 – View of sanitary dump station.

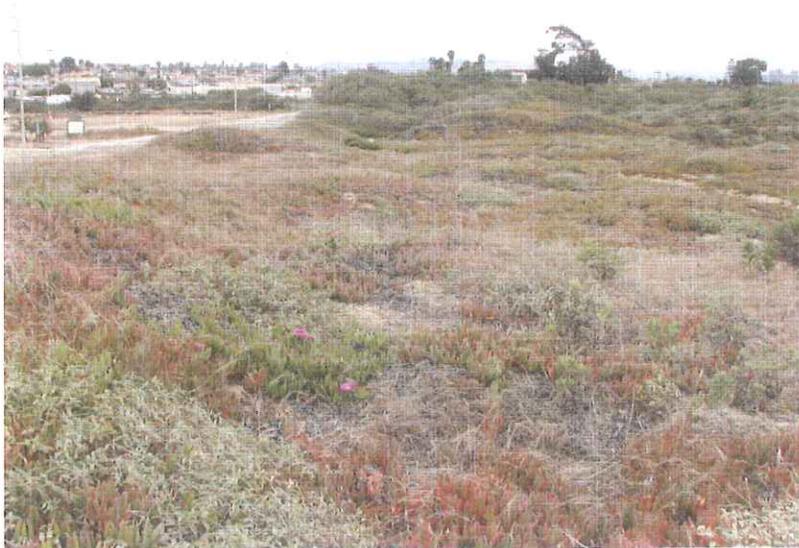
Photo #2 – View east of area south of Grand Avenue for future dump station and equestrian parking.

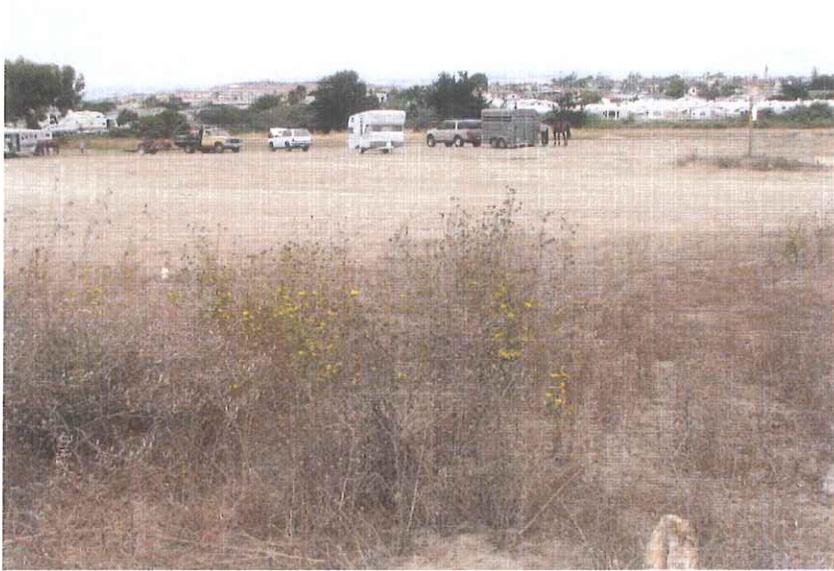
Photo #3 – View northeast from Grand Avenue of existing dirt parking area.

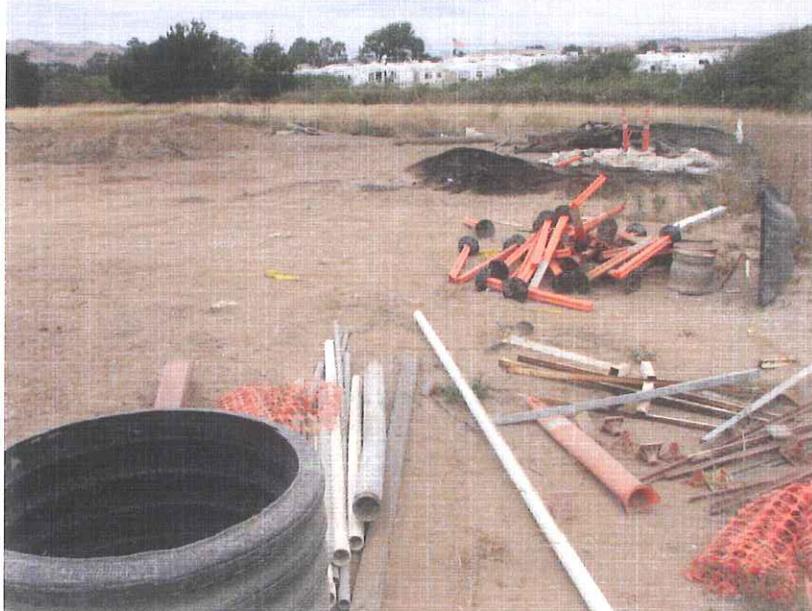
Photo #4 – View north from Grand Avenue showing construction debris along east side of property. Le Sage Rivera Residential Resort in background.

There was house-hold trash throughout the site that consisted primarily of paper and glass. Construction debris was present in the southeast side of the property and consisted of pipe, concrete, metal, and asphalt. No evidence of industrial waste, industrial drums, or industrial batteries was observed during our Site visit. No evidence of stained soil or underground storage tanks were observed during the Site visit.

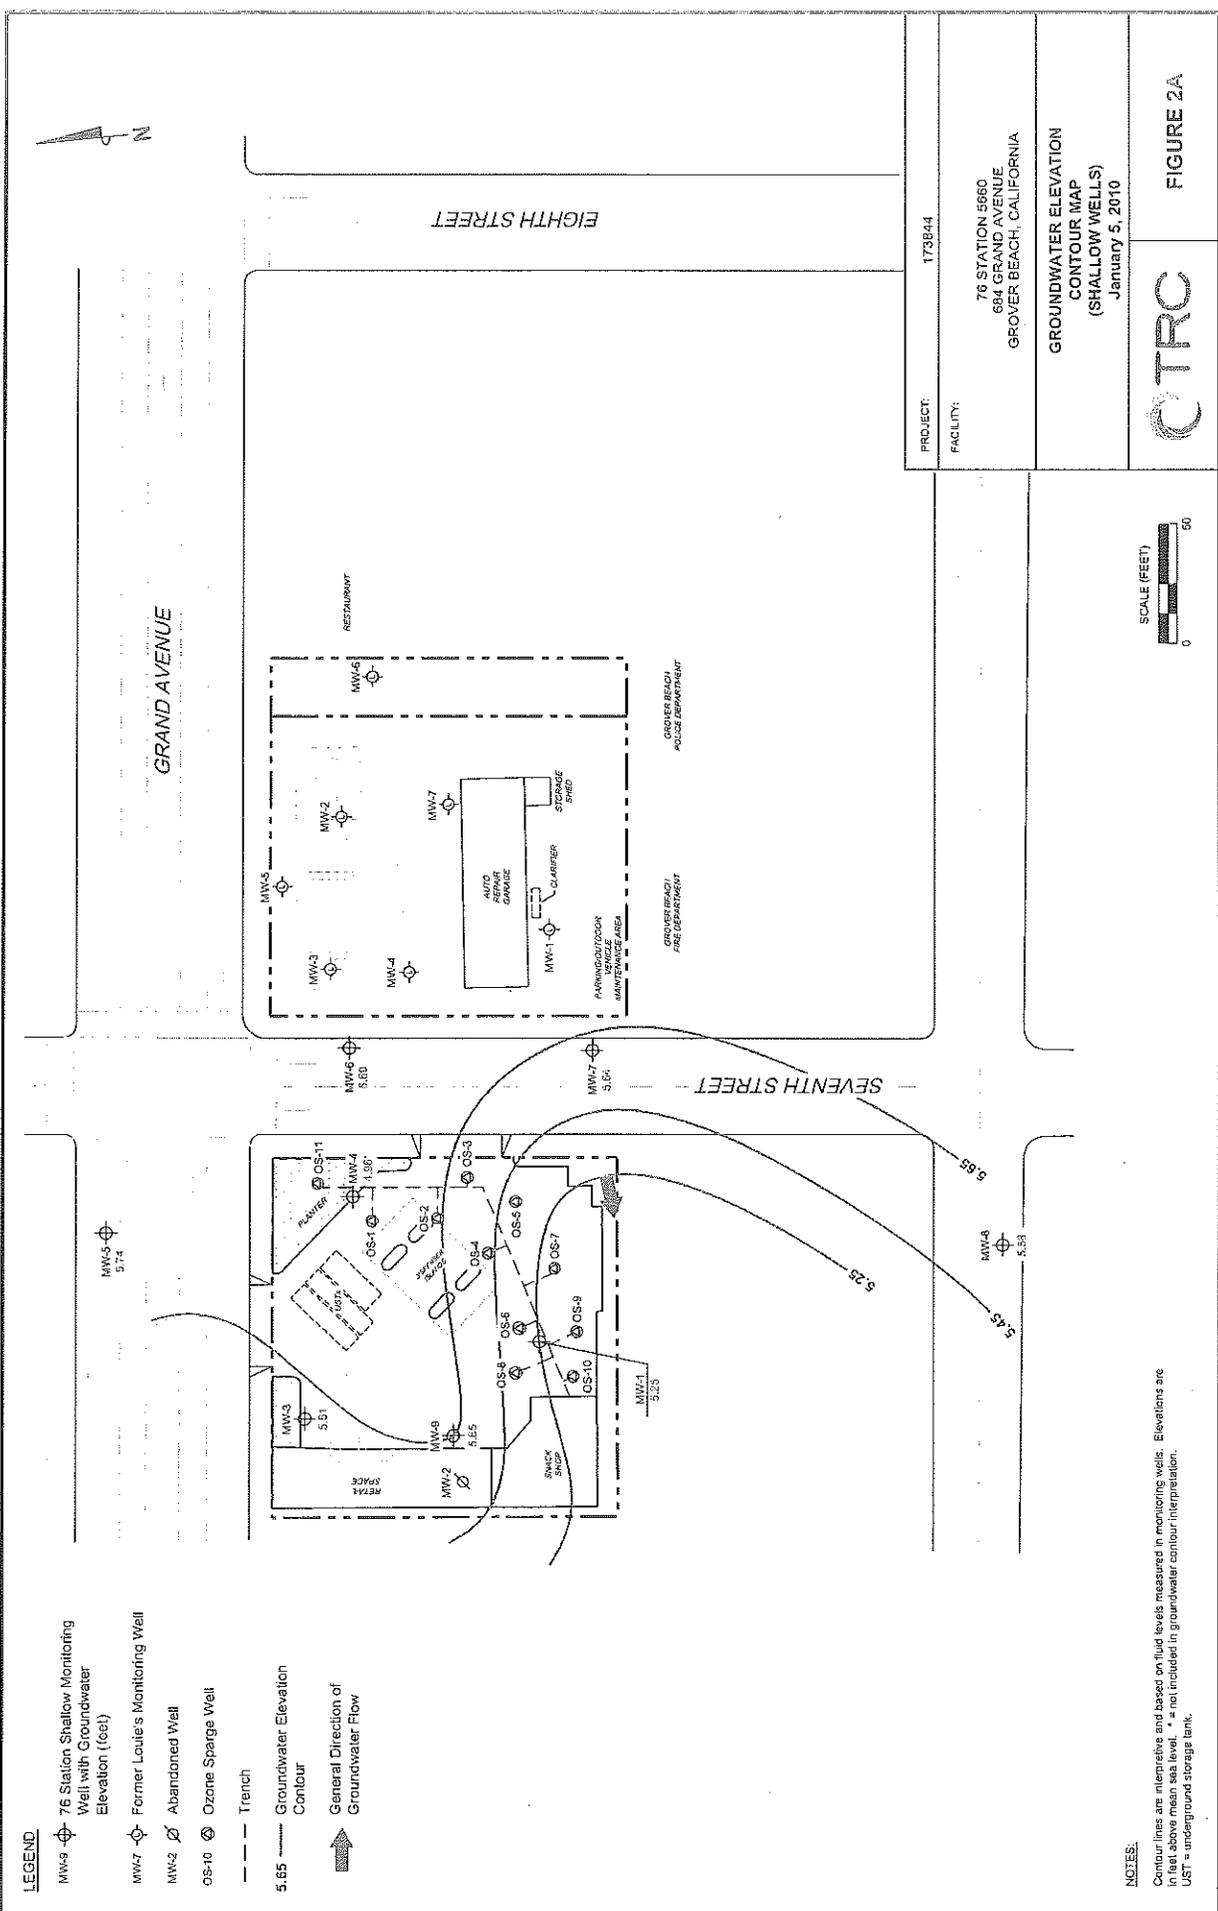
PROJECT:	173844
FACILITY:	76 STATION 5660 684 GRAND AVENUE GROVER BEACH, CALIFORNIA
GROUNDWATER ELEVATION CONTOUR MAP (SHALLOW WELLS) January 5, 2010	
CTRC	
FIGURE 2A

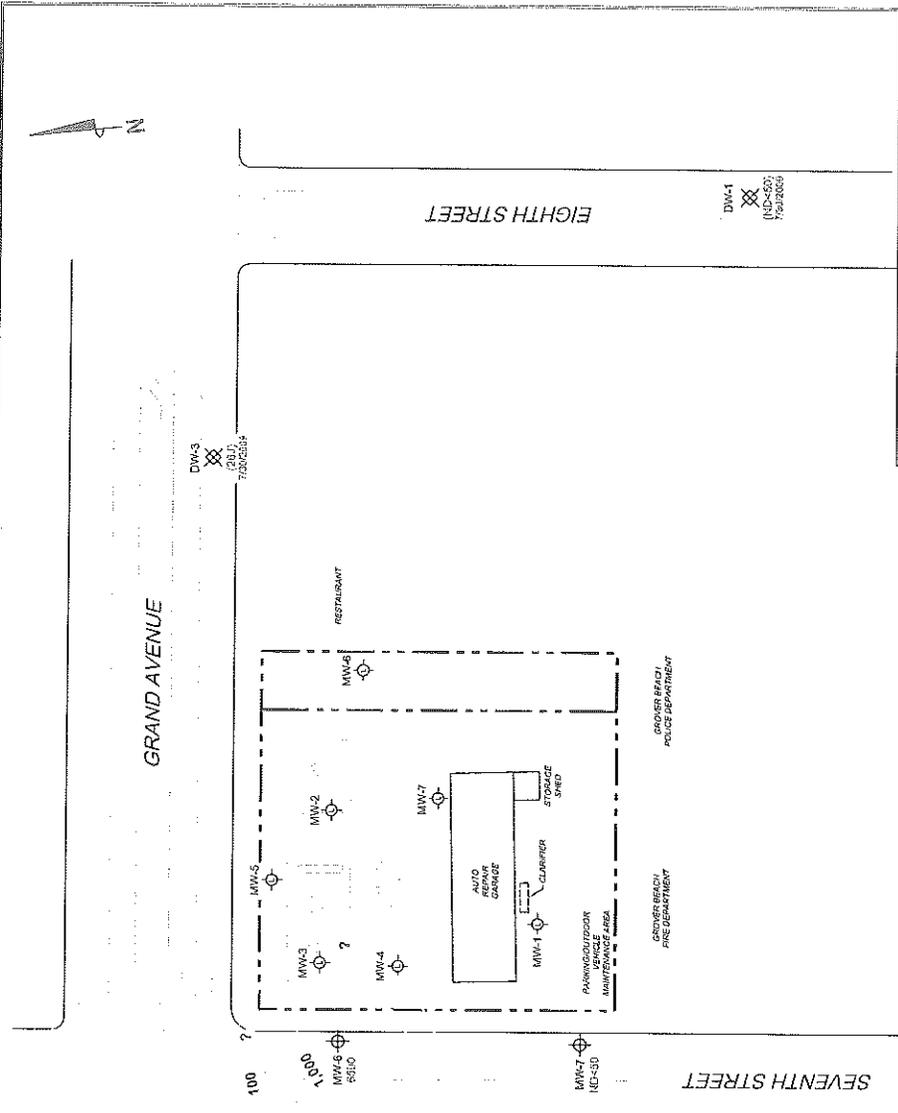
PROJECT:	173844
FACILITY:	76 STATION 5660 684 GRAND AVENUE GROVER BEACH, CALIFORNIA
DISSOLVED-PHASE TPH-G (GC/MS) CONCENTRATION MAP January 5, 2010	
FIGURE 3

Contour lines are interpretive and based on laboratory analysis results of groundwater samples.
 TPH-G (GC/MS) = total petroleum hydrocarbons with gasoline distinction utilizing EPA Method 8280B.
 $\mu\text{g/l}$ = micrograms per liter. ND = not detected at limit indicated on official laboratory report.
 C = estimated concentration, value is between the Method Detection Limit (MDL) and the Practical
 Quantification Limit (PQL). (?) = representative historical value.
 UST = underground storage tank.
